SELLER'S RESIDENTIAL INSPECTION REPORT

14419 Quartz Valley Dr
Fort Jones, CA 96032

04/24/2026

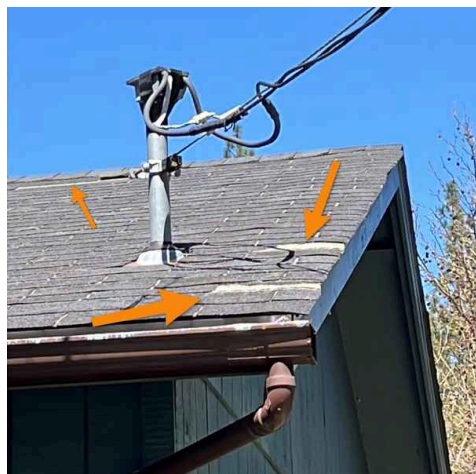
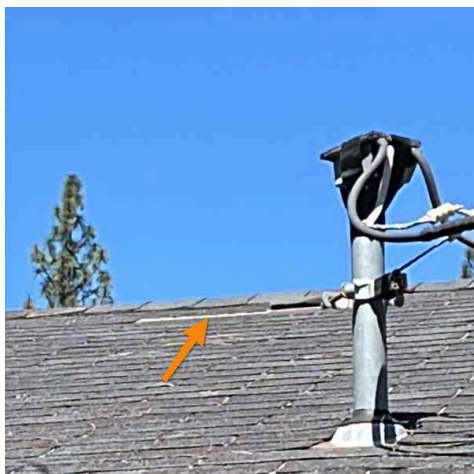
DAMAGED AREAS

Observation: At the time of inspection, one or more areas of the roof covering were observed to be damaged. This may include cracks, tears, loose or missing shingles, or other visible deterioration.

Implication: Damaged roof covering can allow water penetration and may lead to leaks or further deterioration of underlying materials.

Recommendation: Repair damaged areas of the roof covering as needed to restore a watertight seal and prevent future moisture intrusion.

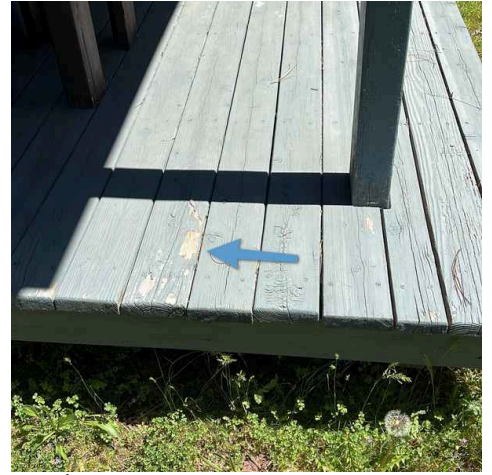
South

Observation: At the time of inspection, one or more areas were observed to have deteriorated, missing, or peeling paint or water seal, leaving exposed surfaces vulnerable to weathering.

Implication: Unsealed or unpainted surfaces are more susceptible to moisture penetration and sun exposure, which can lead to premature deterioration of the underlying materials.

Recommendation: It was recommended that affected areas be properly prepared and coated with a suitable exterior-grade paint or water-repellent sealant to protect against further weathering and extend the service life of the materials.

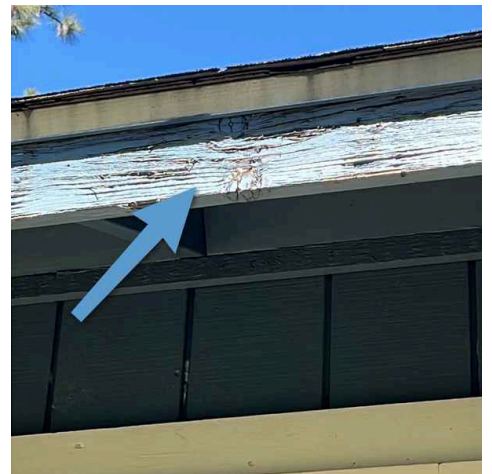
South

Observation: At the time of inspection, one or more areas were observed to have deteriorated, missing, or peeling paint or water seal, leaving exposed surfaces vulnerable to weathering.

Implication: Unsealed or unpainted surfaces are more susceptible to moisture penetration and sun exposure, which can lead to premature deterioration of the underlying materials.

Recommendation: It was recommended that affected areas be properly prepared and coated with a suitable exterior-grade paint or water-repellent sealant to protect against further weathering and extend the service life of the materials.

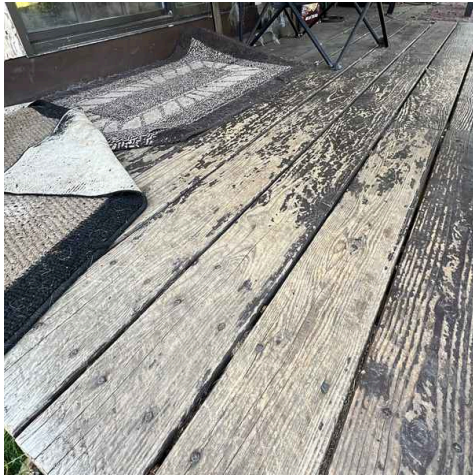
Observation: At the time of inspection, one or more areas were observed to have deteriorated, missing, or peeling paint or water seal, leaving exposed surfaces vulnerable to weathering.

Implication: Unsealed or unpainted surfaces are more susceptible to moisture penetration and sun exposure, which can lead to premature deterioration of the underlying materials.

Recommendation: It was recommended that affected areas be properly prepared and coated with a suitable exterior-grade paint or water-repellent sealant to protect against further weathering and extend the service life of the materials.

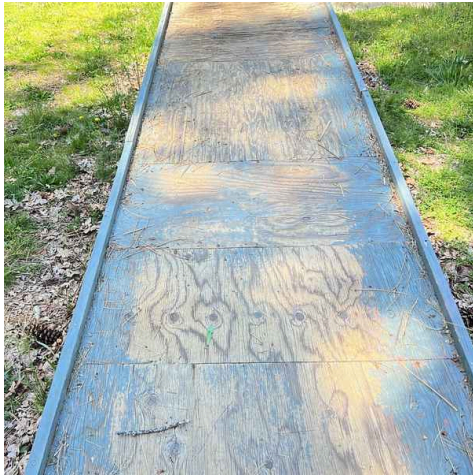
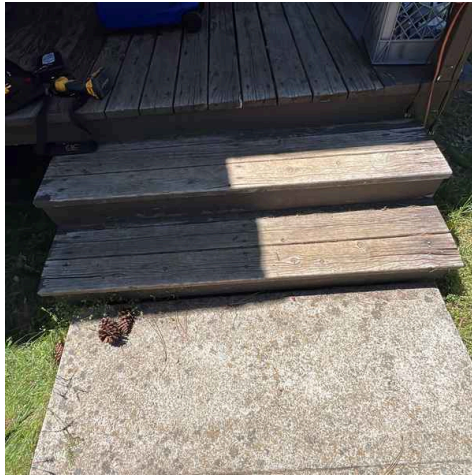
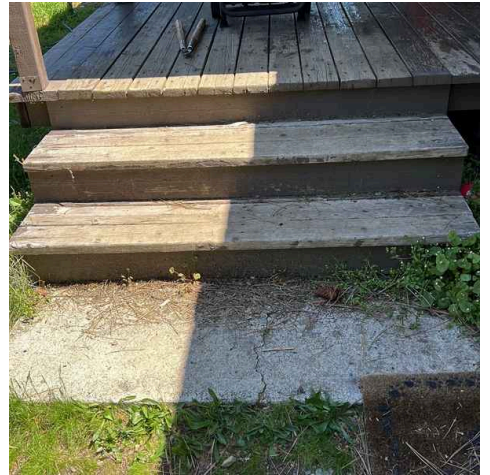
Observation: At the time of inspection, one or more areas were observed to have deteriorated, missing, or peeling paint or water seal, leaving exposed surfaces vulnerable to weathering.

Implication: Unsealed or unpainted surfaces are more susceptible to moisture penetration and sun exposure, which can lead to premature deterioration of the underlying materials.

Recommendation: It was recommended that affected areas be properly prepared and coated with a suitable exterior-grade paint or water-repellent sealant to protect against further weathering and extend the service life of the materials.

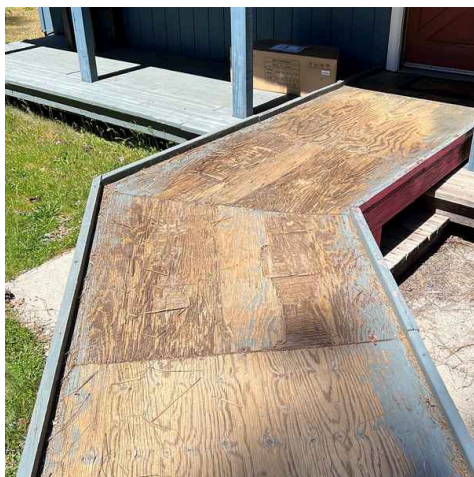
MOISTURE DAMAGE OR DETERIORATION

Observation: At the time of inspection, moisture-damaged areas were observed at the stair structure.

Implication: Moisture-damaged stair components can continue to deteriorate if left uncorrected and may affect the long-term condition, function, or support of the stair structure, depending on the location and extent of the damage.

Recommendation: It is recommended that the moisture-damaged areas be evaluated and correctly repaired by a qualified professional, and that affected materials be treated or replaced as needed to help inhibit further deterioration.

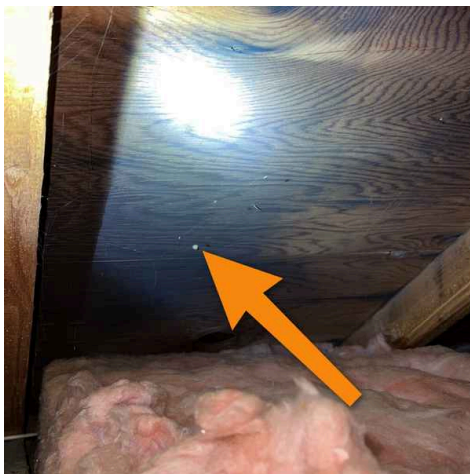
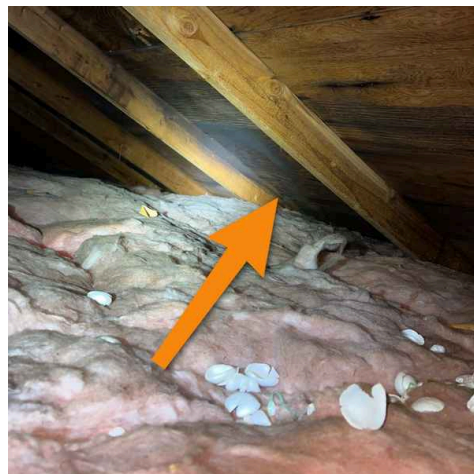
Observation: At the time of inspection, evidence of biological growth was observed on attic surfaces. Testing was not performed to confirm the presence of active growth or to identify specific species. Mold in attics rarely affects indoor air quality in living spaces. Contributing factors may include inadequate attic ventilation, exhaust vents from bathrooms, kitchens, or laundry areas terminating into the attic, or other sources of excess moisture. It could not be determined if this condition represents an ongoing seasonal moisture problem.

Implication: Biological growth indicates that attic humidity or ventilation may not be balanced. Continued moisture conditions can lead to ongoing growth and potential damage to wood materials.

Recommendation: It is recommended that the attic be evaluated by a qualified specialist to determine whether remediation is needed and to identify any contributing ventilation or moisture issues. Alternatively, conditions may be monitored throughout the year to assess whether the issue persists. Mold testing may be ordered from Shasta Premier Inspection Group (530-598-7856 or www.ShastaPremier.com).

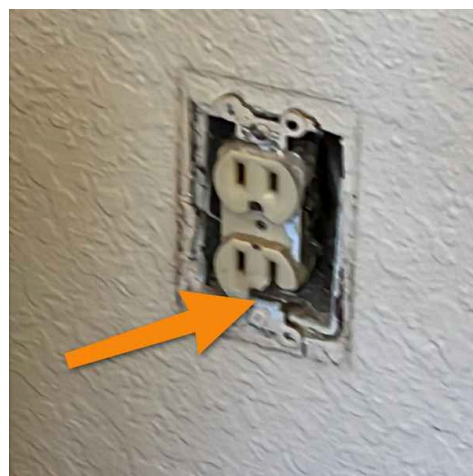
DAMAGED SWITCH OR RECEPTACLE

Observation: At the time of inspection, one or more switches or receptacles were observed to be damaged.

Implication: Damaged electrical devices may expose live components, creating a potential shock or fire hazard.

Recommendation: It is recommended that damaged switches or receptacles be replaced for safety.

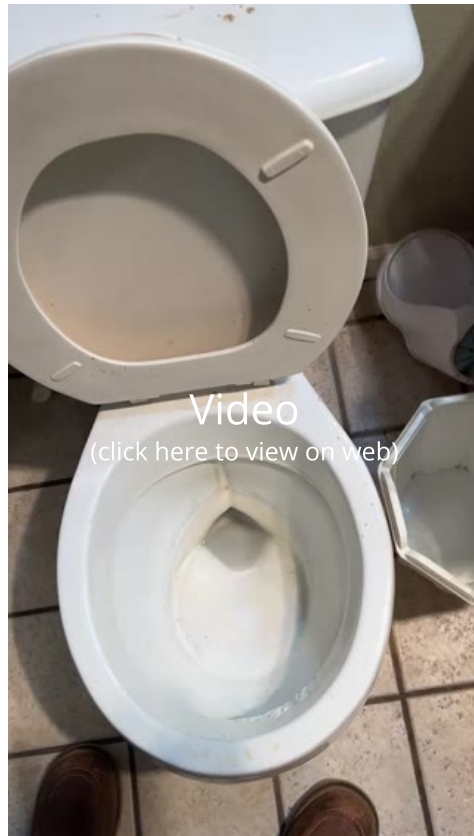
TOILET FIXTURE LOOSE

Implication: A loose toilet fixture can affect the seal at the base and may allow movement that can lead to leaks, moisture damage, or further loosening over time.

Recommendation: It is recommended that the loose toilet fixture be correctly secured and repaired by a qualified professional as needed.

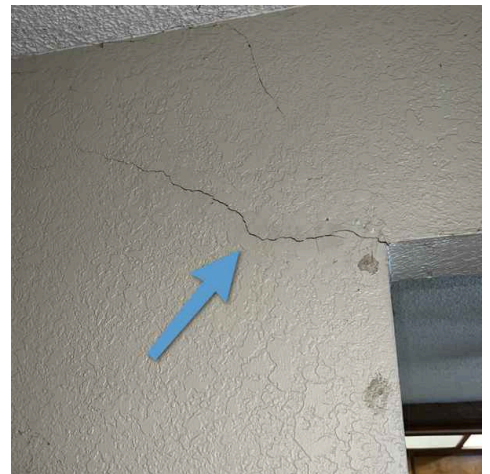
Living Room

Implication: While not necessarily a structural concern, cracks of this type can result from localized settling, framing movement, or variations in humidity and temperature. Continued widening or new cracking could suggest ongoing movement.

Recommendation: Repair cracks as desired for appearance and monitor periodically for changes. If cracking worsens or recurs after repair, have the area evaluated by a qualified contractor or structural specialist.

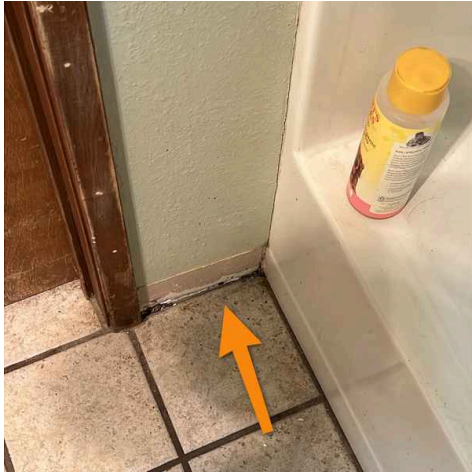
Implication: Missing trim primarily affects the finished appearance of the interior and is typically considered cosmetic in nature. In some cases, however, it may leave small gaps that allow drafts or debris accumulation.

Recommendation: It is recommended that missing trim be repaired or replaced for proper finish and appearance.

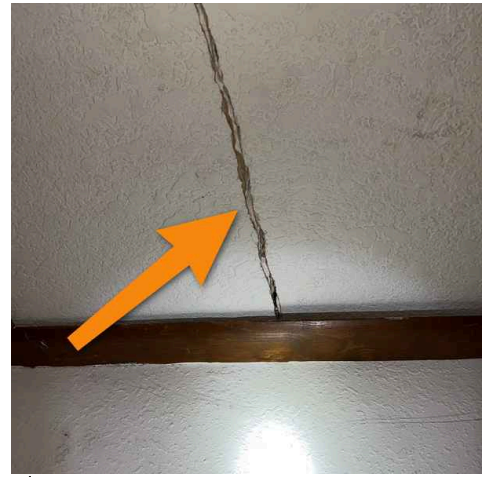
Closet

Implication: Damaged or deteriorated ceiling materials can affect the finished appearance of the area and may allow further deterioration depending on the cause and extent of the condition.

Recommendation: It is recommended that the affected ceiling areas be correctly repaired or replaced by a qualified professional as needed.

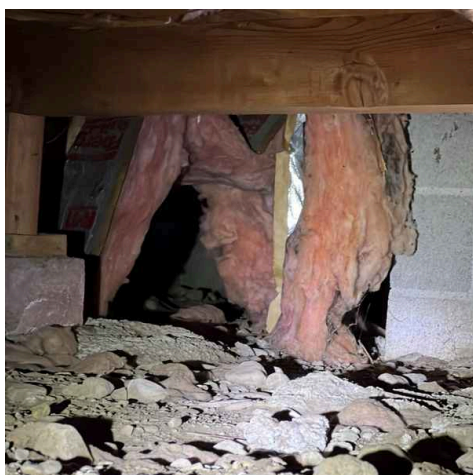
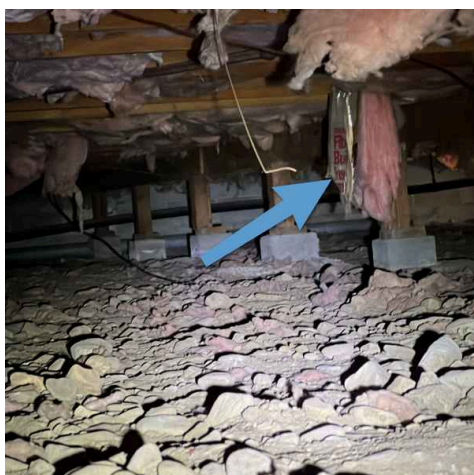
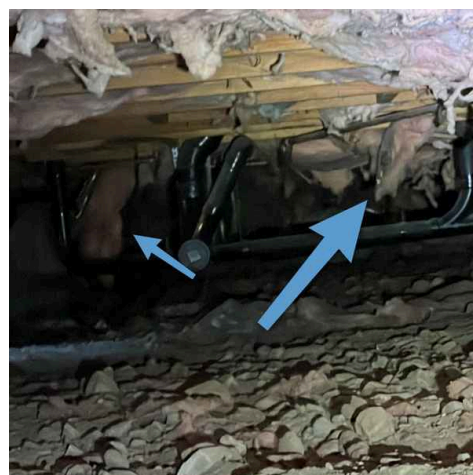
Implication: Loose or damaged insulation can reduce energy efficiency and allow heat loss through the floor system.

Recommendation: It was recommended that damaged or displaced insulation be repaired or replaced as needed to restore consistent coverage and thermal performance.
